**United States Environmental Protection Agency
Criminal Investigation Division
Investigative Activity Report**

Fortymile: [REDACTED] Placer Mine Investigation
(APMA [REDACTED])

Mine Discharge Investigation at the APMA [REDACTED] Mine
(08/19/13)

Mine Discharge Investigation at the APMA [REDACTED] [REDACTED] Mine (08/19/13)

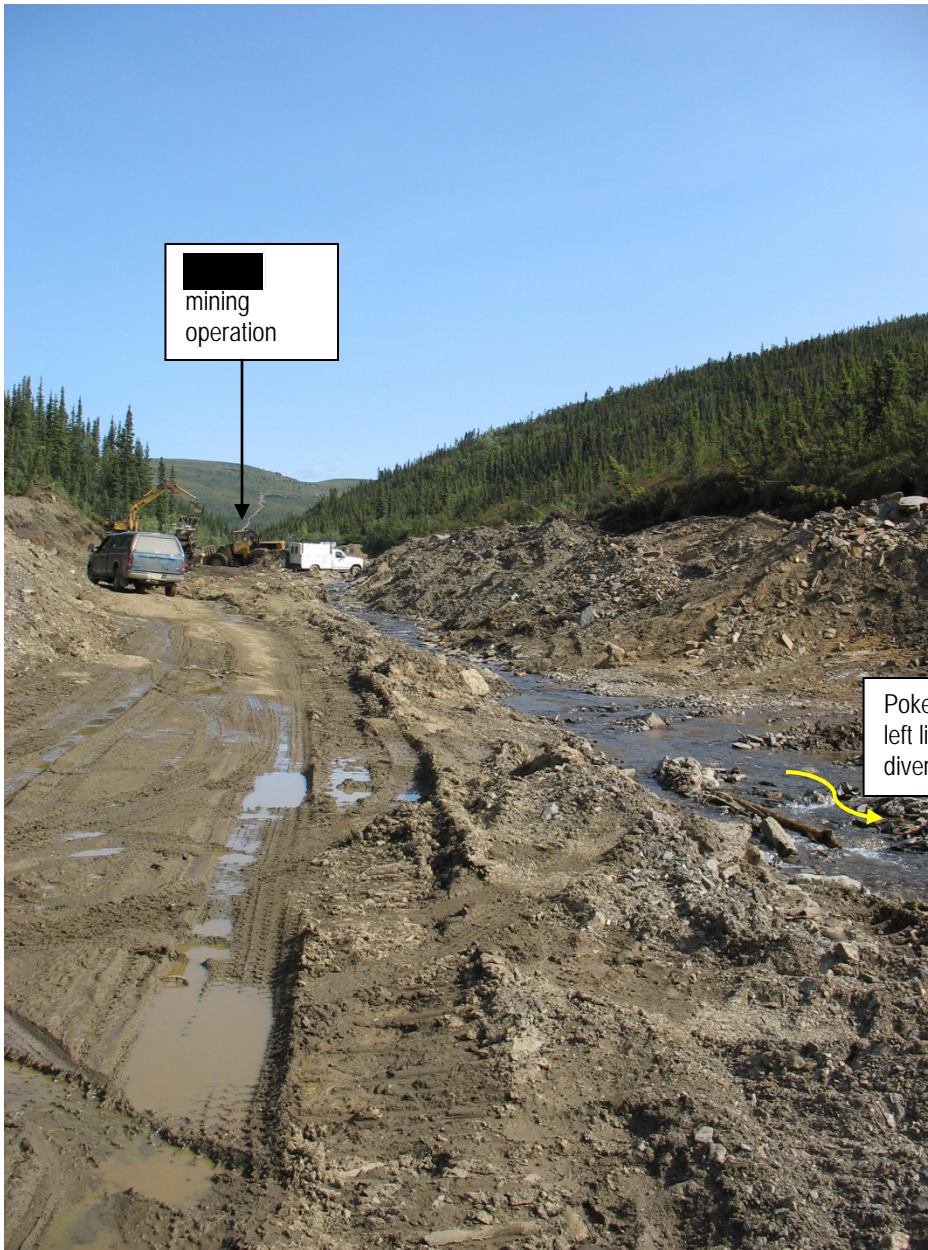
POA-1988-89, APMA [redacted] Poker Creek
Operator: [redacted]
Photo shows [redacted] mining operation. Blue vehicle is where we parked the state of Alaska vehicle, below the operations. The Poker Creek Valley is fairly narrow and steep, ~ 10% grade, valley bottom . Mining is occurring at the toe of slope on both sides of the valley. Creek is diverted to either one side or the other of the valley. In this photo, creek is on the left limit. The road is up the middle of the valley.
Photo 1

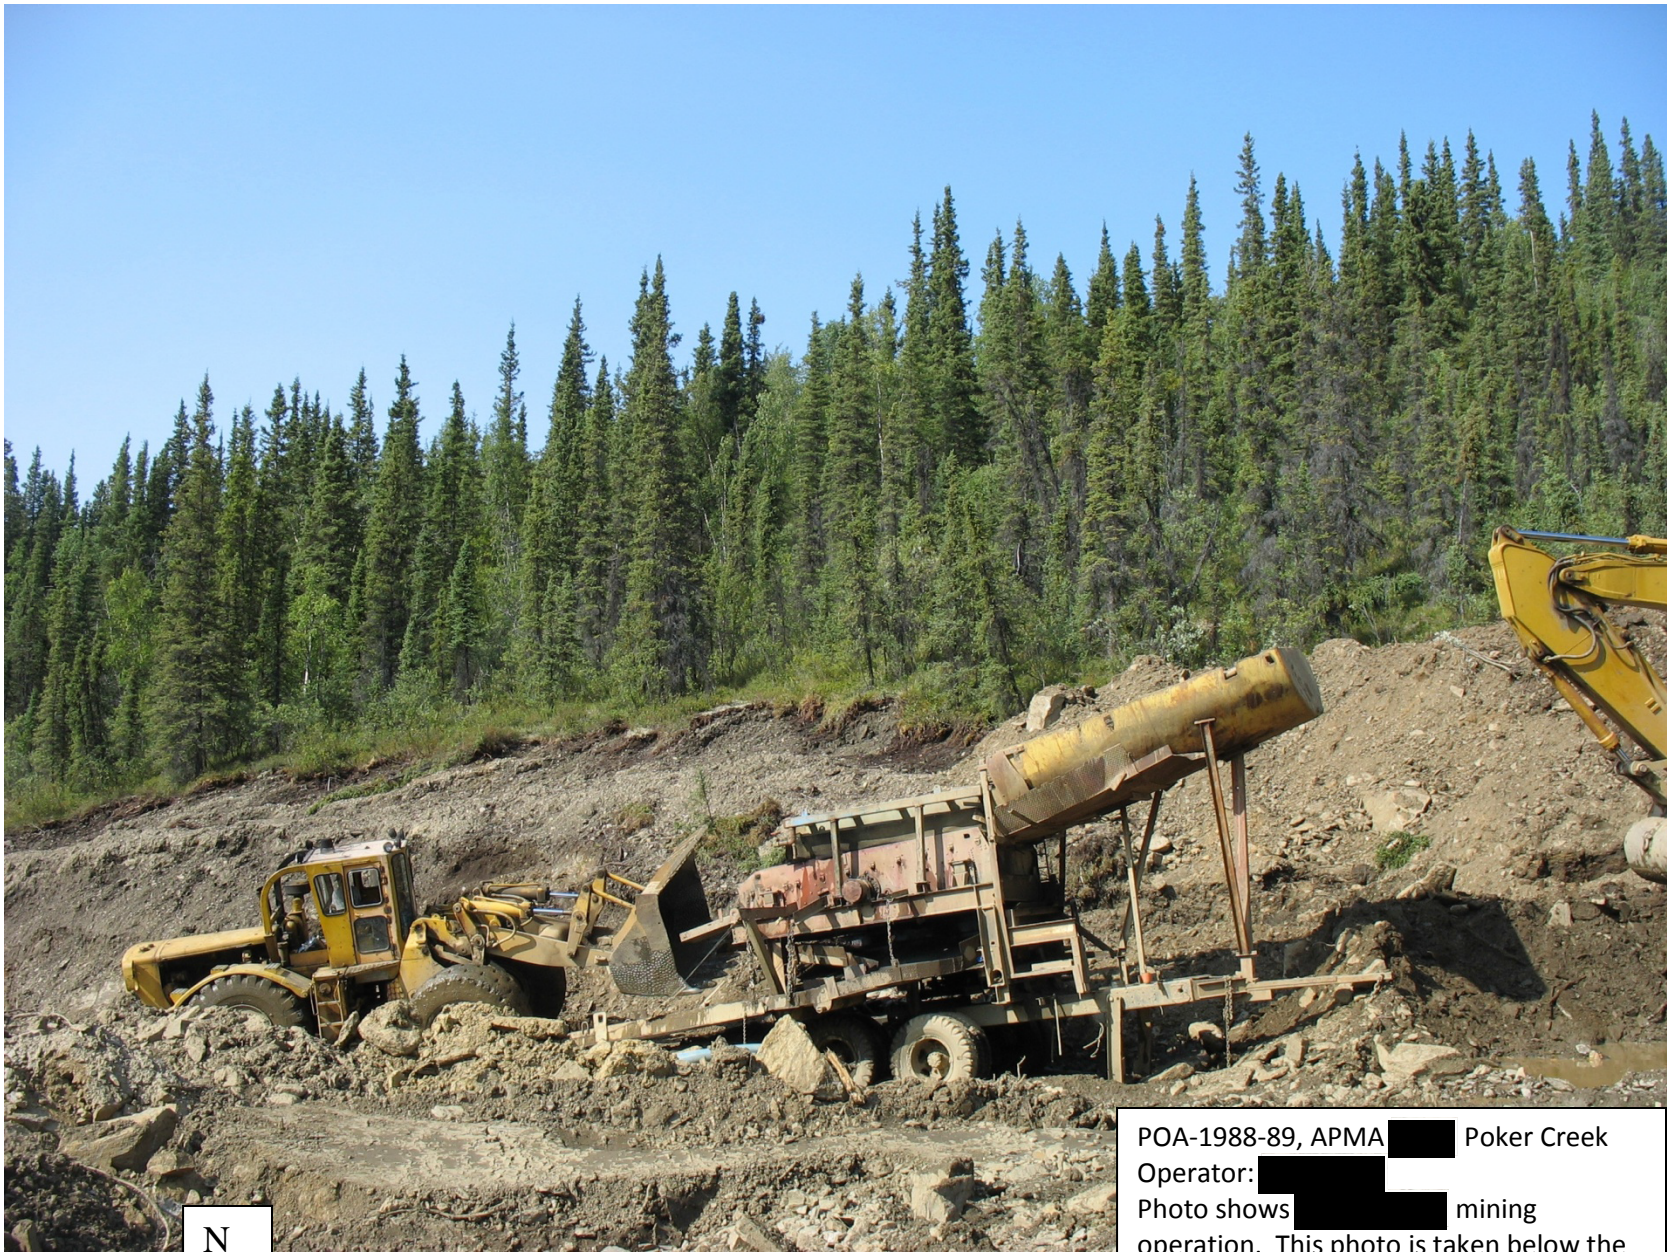
POA-1988-89, APMA [REDACTED] Poker Creek
Operator: [REDACTED]
Photo shows [REDACTED] mining
operation. This photo is taken below the
previous one.
Photo 3

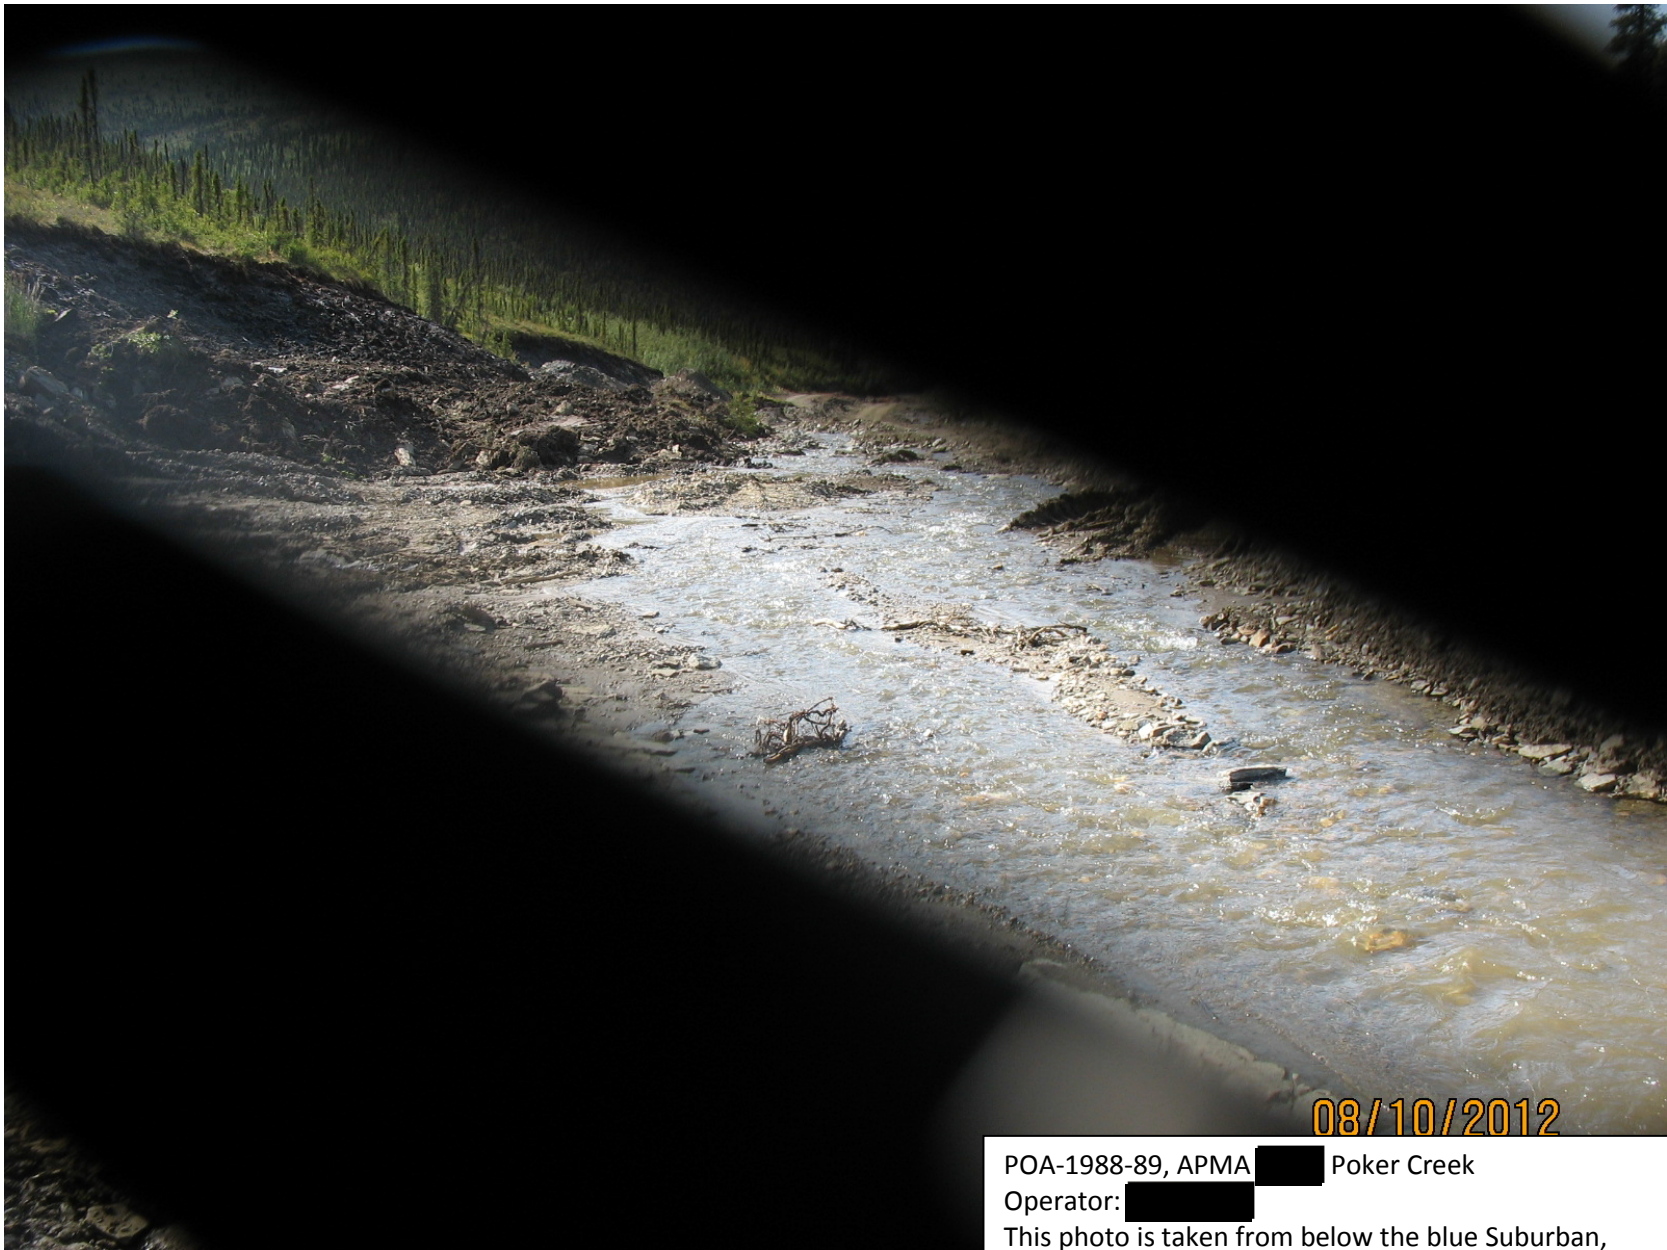
Photo 5

On a number of photos from this site visit, the shutter got stuck.

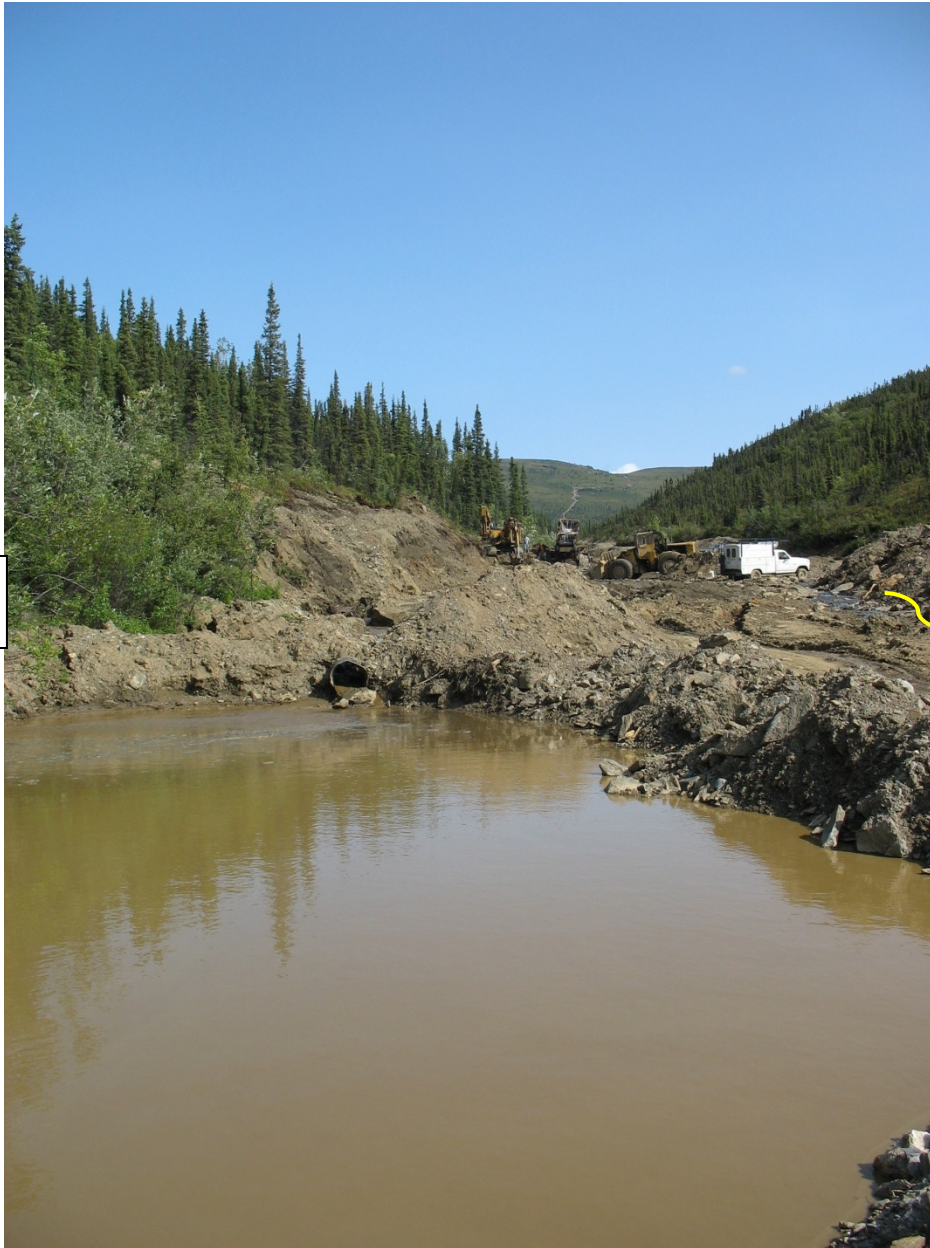
right limit
settling pond

Poker Creek
left limit
diversion
